## **Appendix 1**

### **Photograph Log**

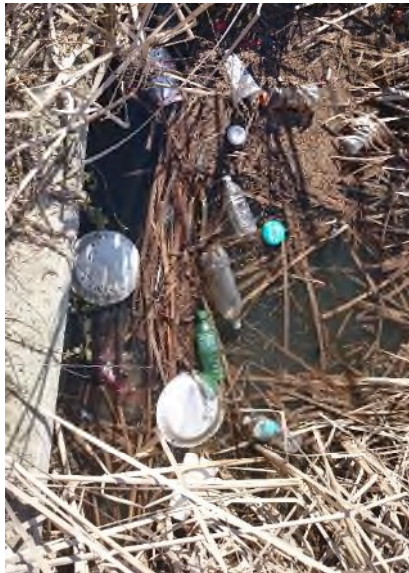
**Photograph 56. Hopewell High School Stormwater Management Facility: Alternate view of inlet to pond with trash visible.**

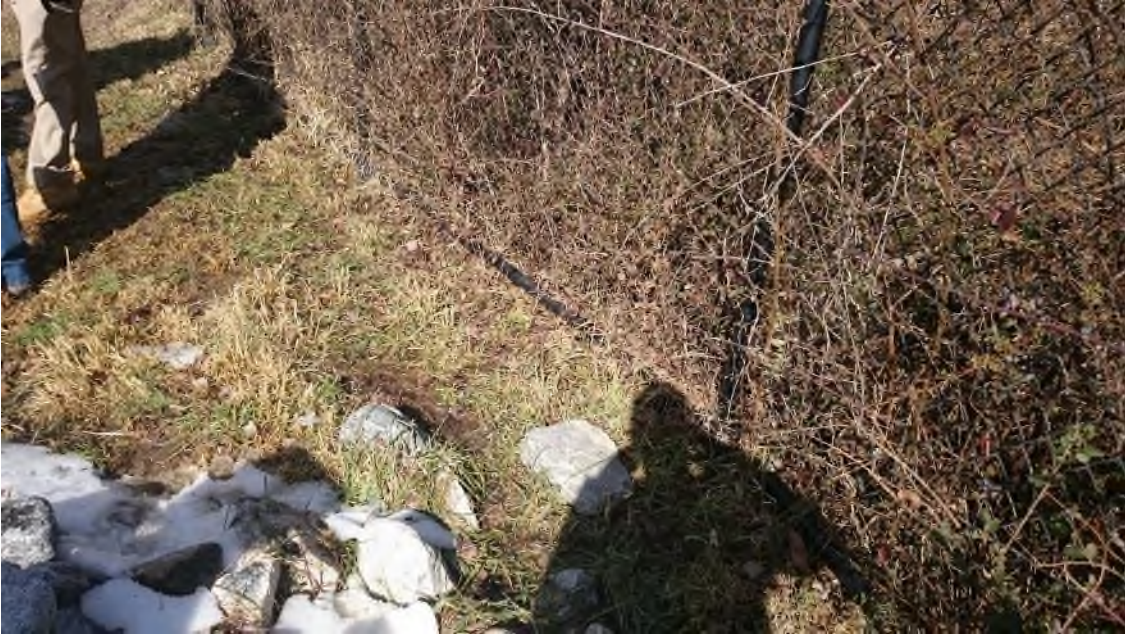
**Photograph 57. Hopewell High School Stormwater Management Facility: Wetland erosion stabilized with riprap.**

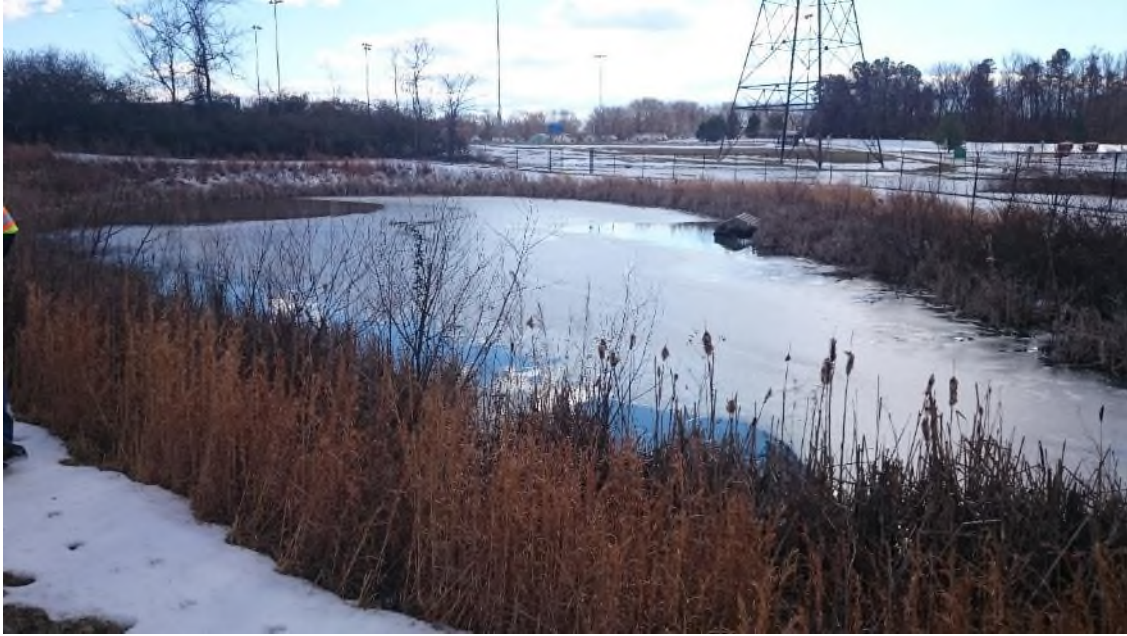
**Photograph 59. Hopewell High School Stormwater Management Facility: Opposite side of the pond pictured in Photograph 50.**

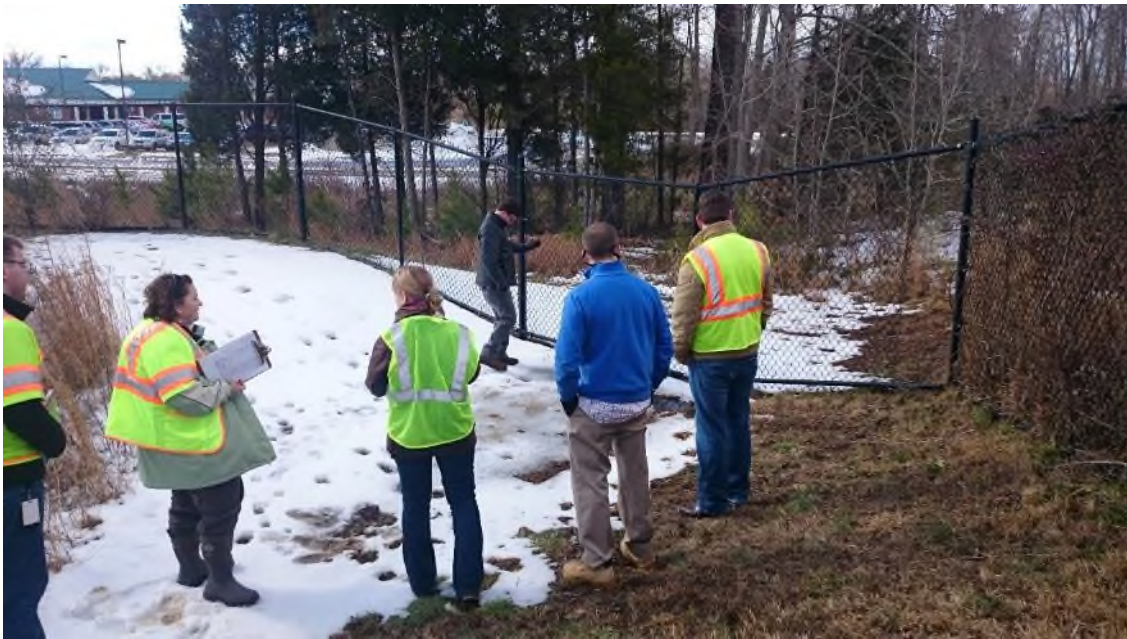
**Photograph 60. Hopewell High School Stormwater Management Facility: Stormwater retention pond emergency spillway.**

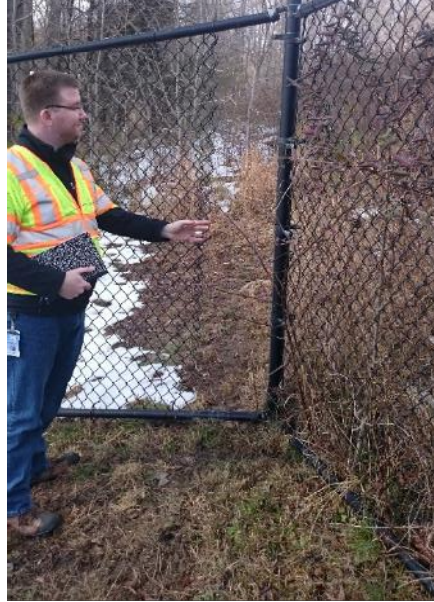
**Photograph 61. Hopewell High School Stormwater Management Facility: Gap in the fence surrounding the pond near the emergency spillway.**

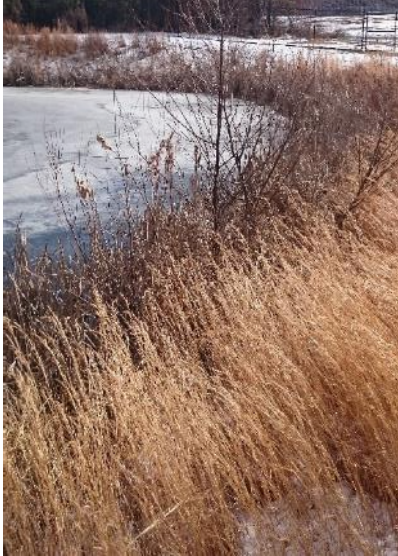
**Photograph 63. Hopewell High School Stormwater Management Facility: Small tree growing among the cattails on the bank of the pond.**

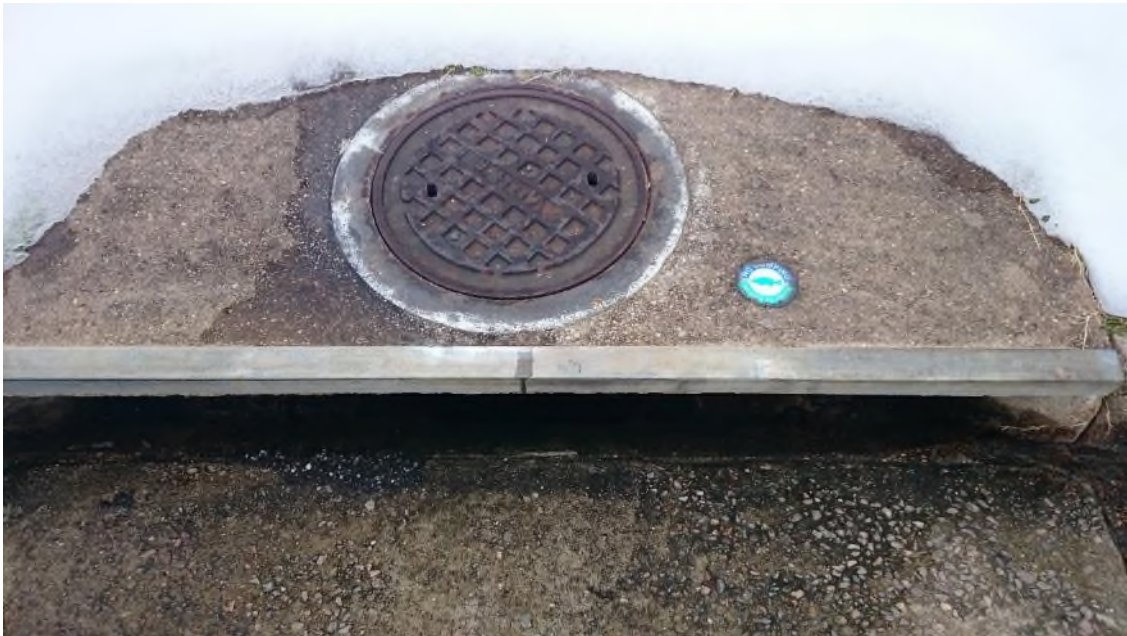
**Photograph 64. Westmoreland Development Private Stormwater Management Facility: Storm drain on road.**

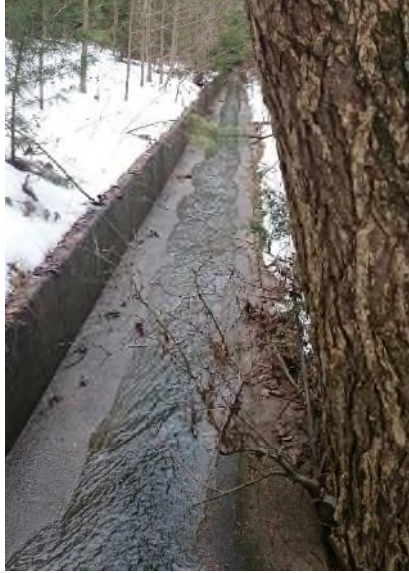
**Photograph 65. Westmoreland Development Private Stormwater Management Facility:  
Downstream view of channel adjacent to the stormwater management facility.**

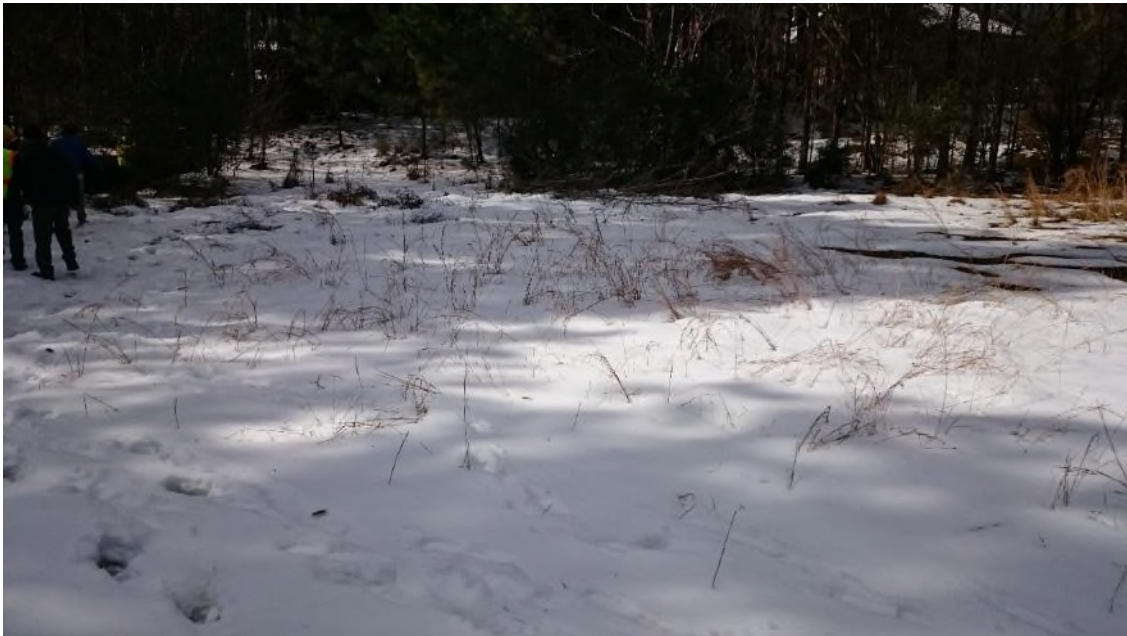
**Photograph 66. Westmoreland Development Private Stormwater Management Facility:  
Facility 1-56 as identified by the stormwater management facility database.**

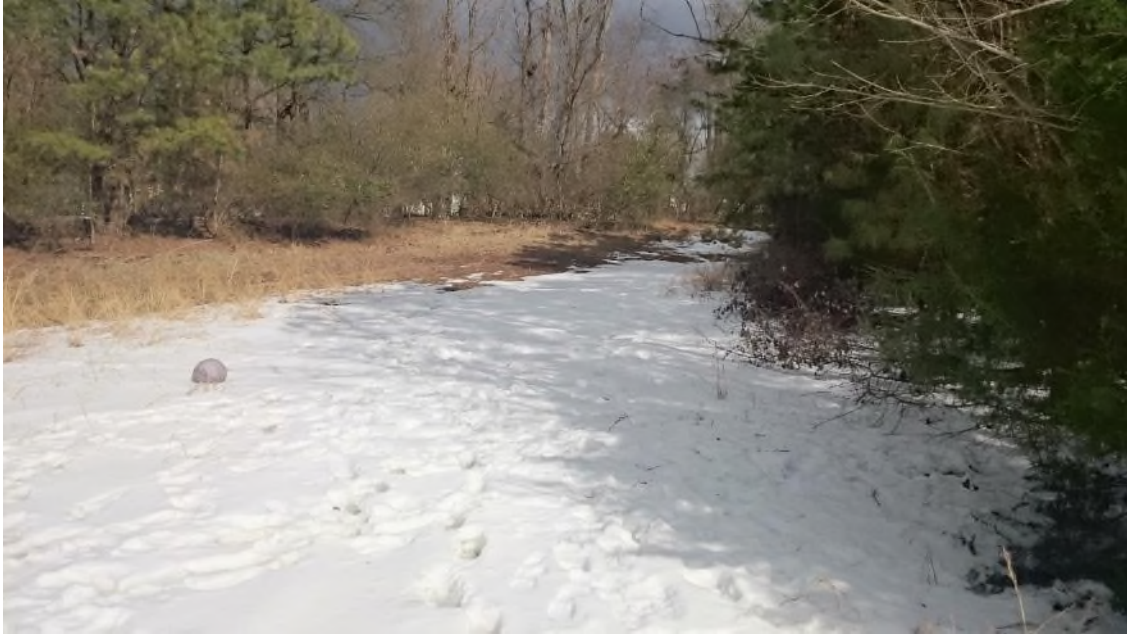
**Photograph 67. Westmoreland Development Private Stormwater Management Facility:  
Facility 1-56 as identified by the stormwater management facility database.**

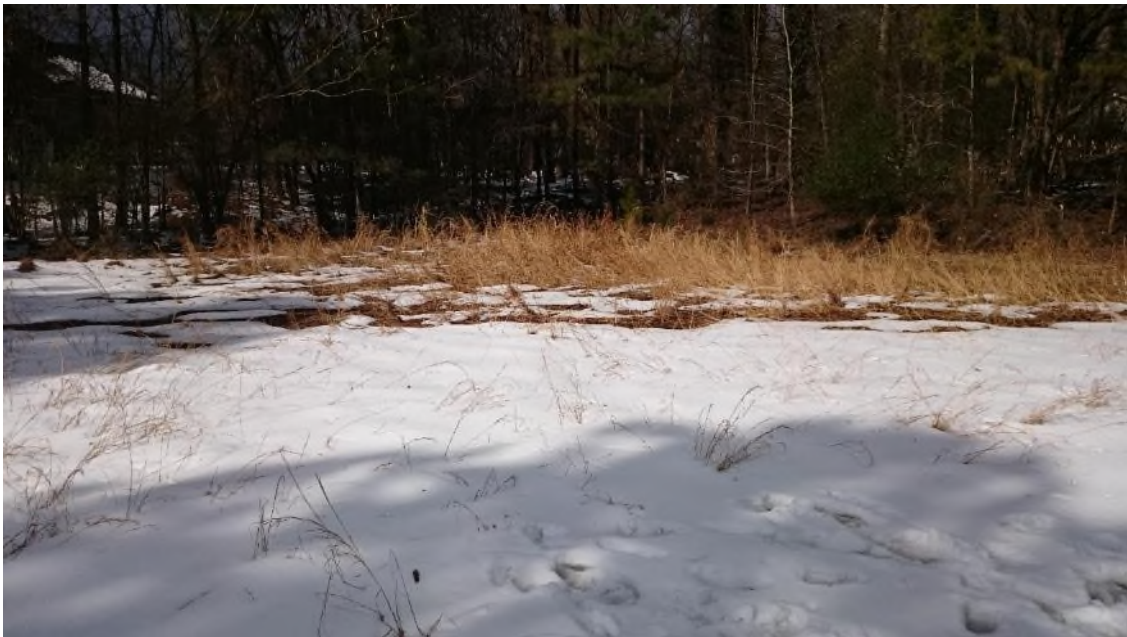
**Photograph 68. Westmoreland Development Private Stormwater Management Facility:  
View across Facility 1-56 as identified by the stormwater management facility database  
from channel (behind photographer).**

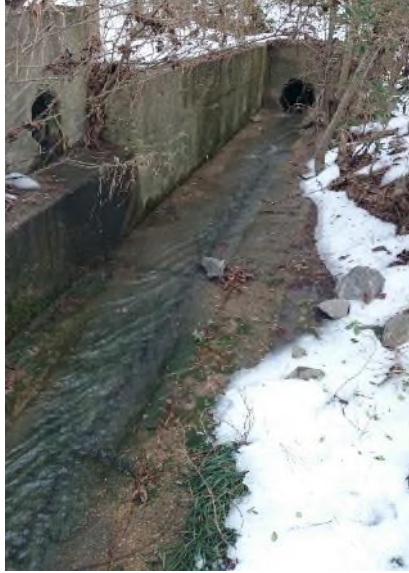
**Photograph 69. Westmoreland Development Private Stormwater Management Facility:  
End of channel at the far downhill portion of Facility 1-56 as identified by the stormwater  
management facility database.**

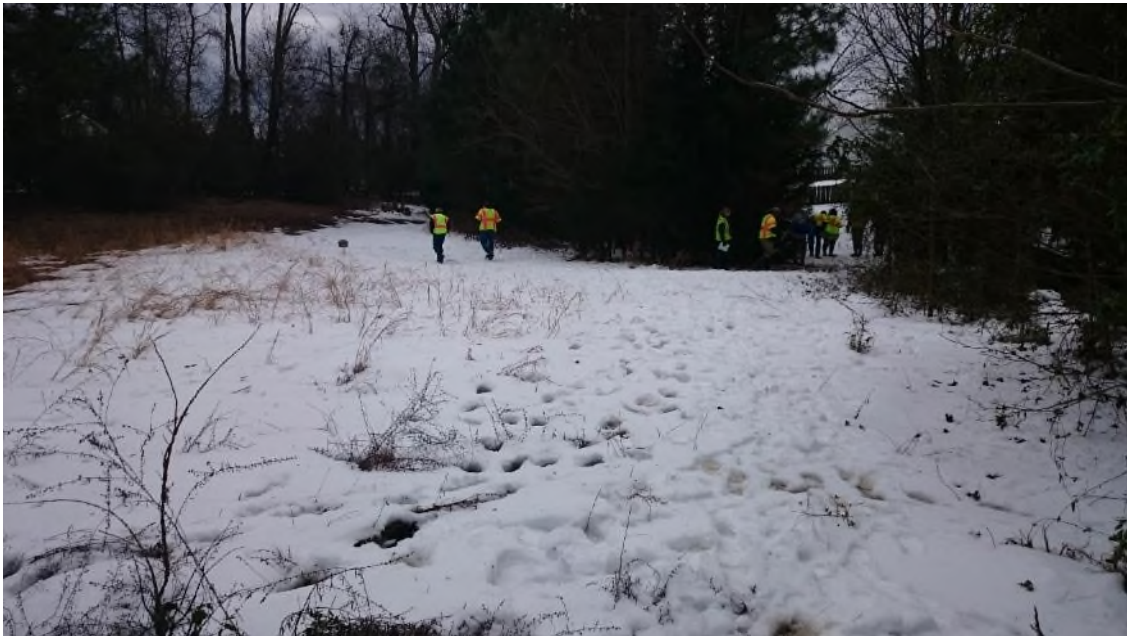
**Photograph 70. Westmoreland Development Private Stormwater Management Facility:  
Looking uphill from Photograph 69, over Facility 1-56 as identified by the stormwater  
management facility database.**

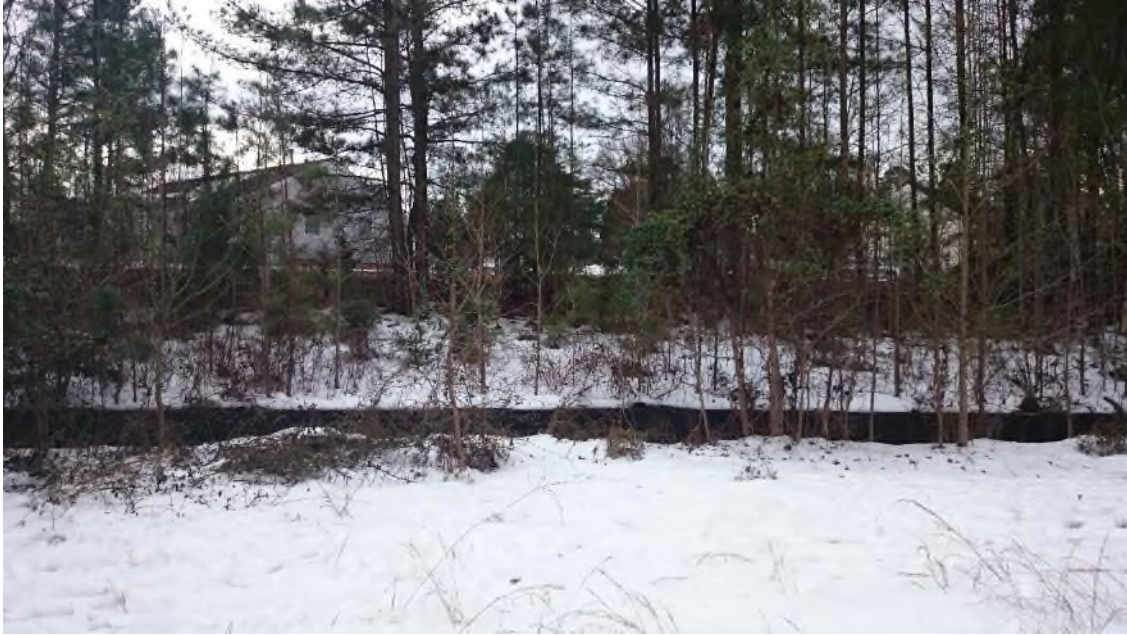
**Photograph 71. Westmoreland Development Private Stormwater Management Facility:  
Embankment next to channel pictured in Photograph 65 for Facility 1-56 as identified by  
the stormwater management facility database.**

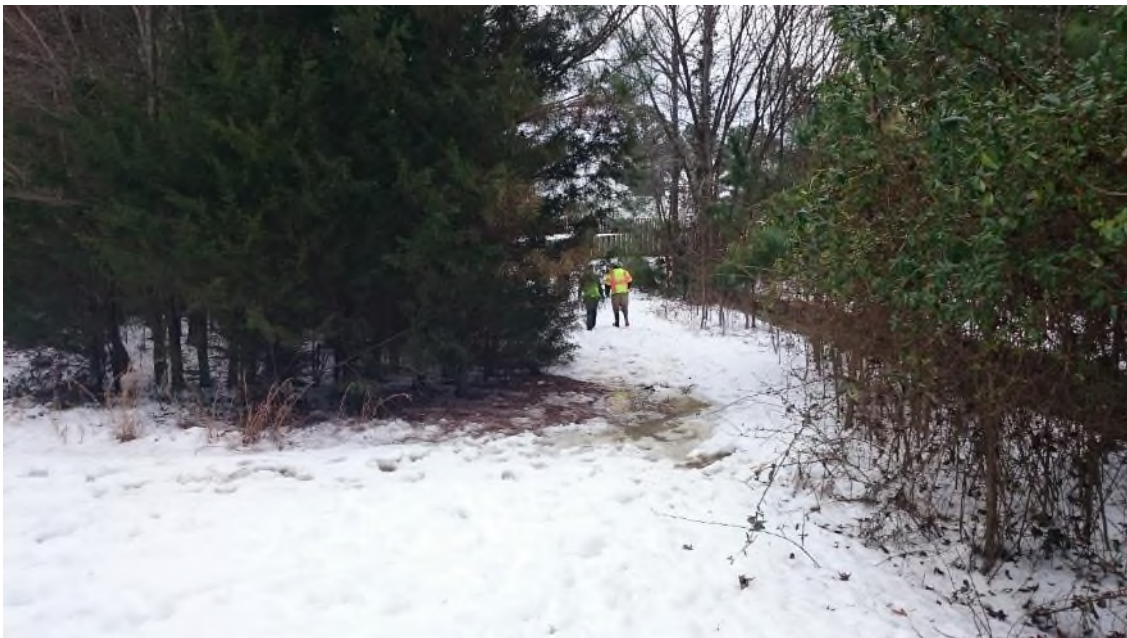
**Photograph 72. Westmoreland Development Private Stormwater Management Facility:  
Uphill view with channel in right of photograph of Facility 1-56 as identified by the  
stormwater management facility database.**

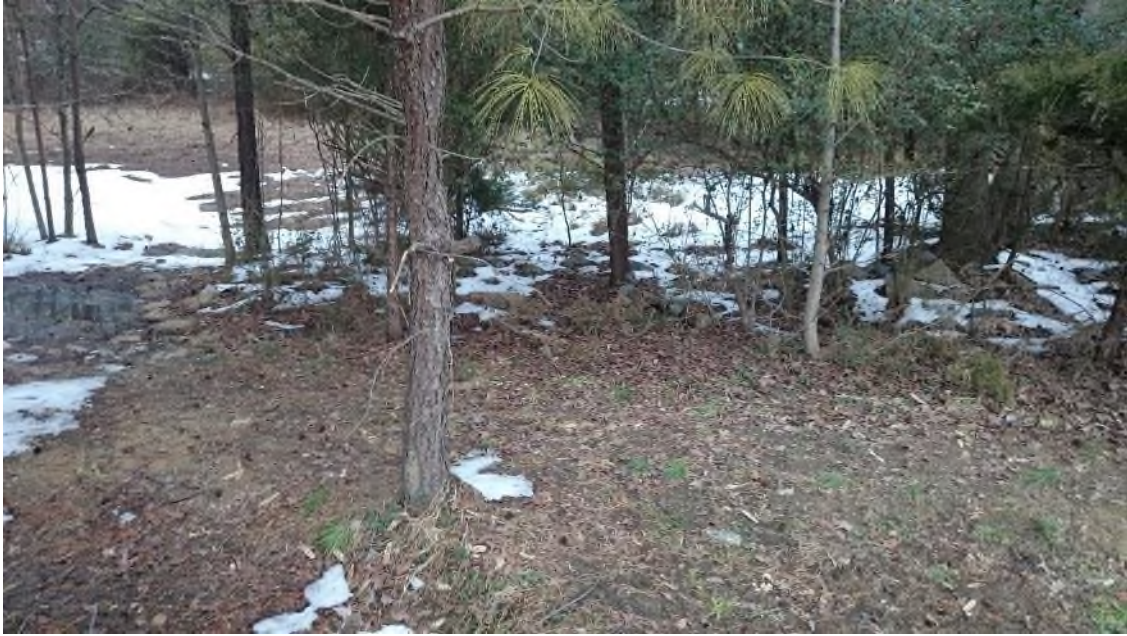
**Photograph 73. Westmoreland Development Private Stormwater Management Facility: Riprap next to channel entrance to Facility 1-56 as identified by the stormwater management facility database.**

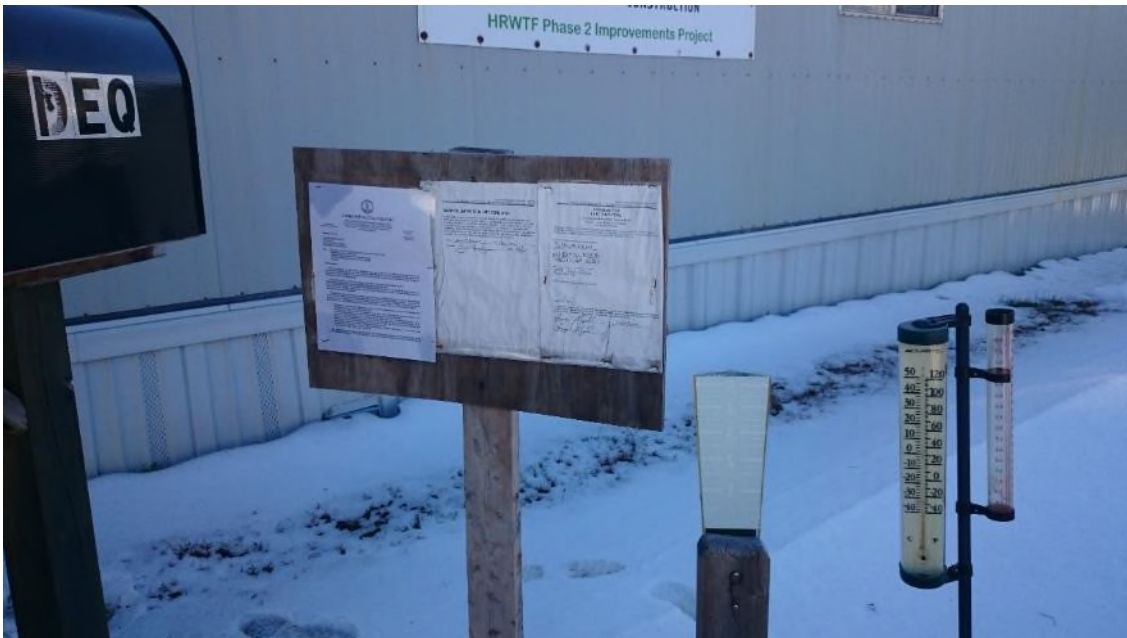
**Photograph 74. Hopewell Regional Wastewater Treatment Plant Construction Site: DEQ mailbox, rain gauge, and permits.**

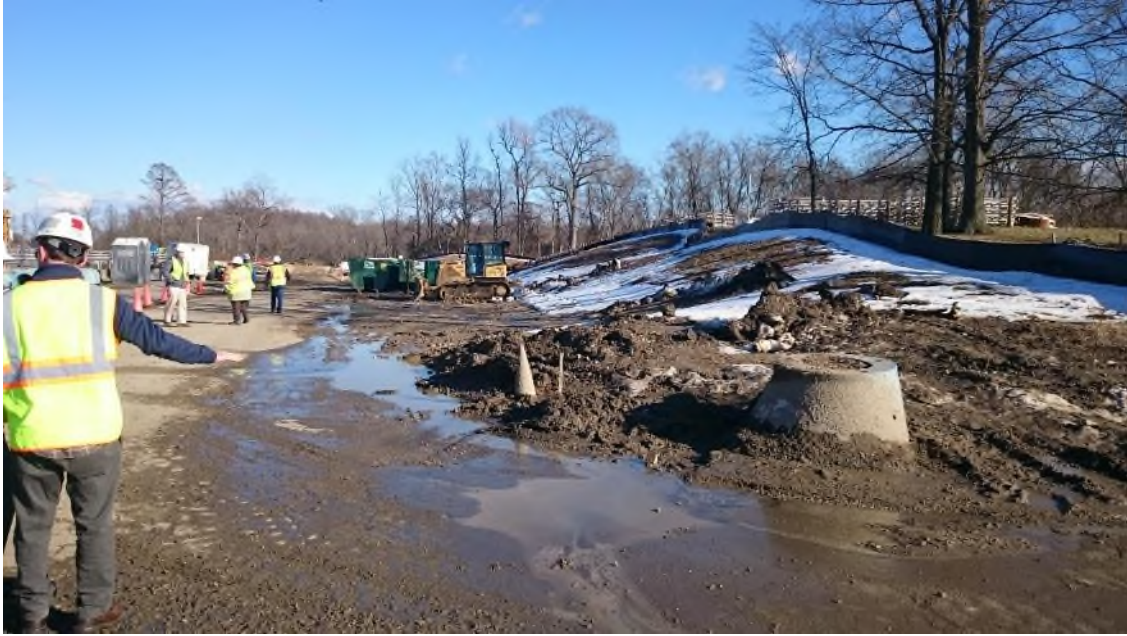
**Photograph 75. Hopewell Regional Wastewater Treatment Plant Construction Site:  
Disturbed embankment.**

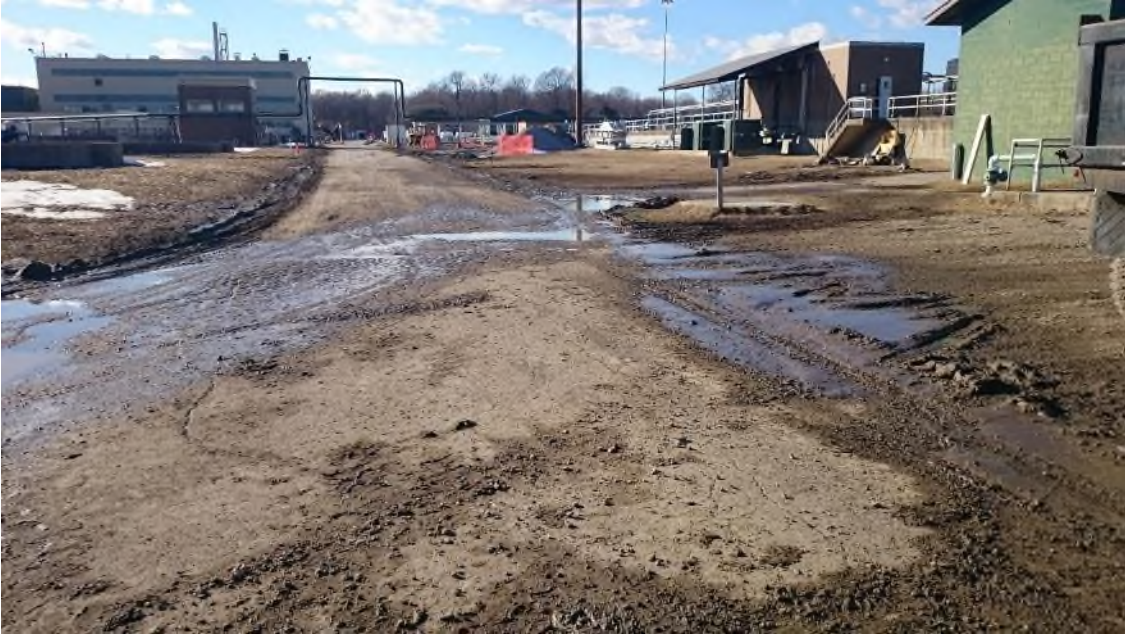
**Photograph 77. Hopewell Regional Wastewater Treatment Plant Construction Site: Internal road exit from construction site.**

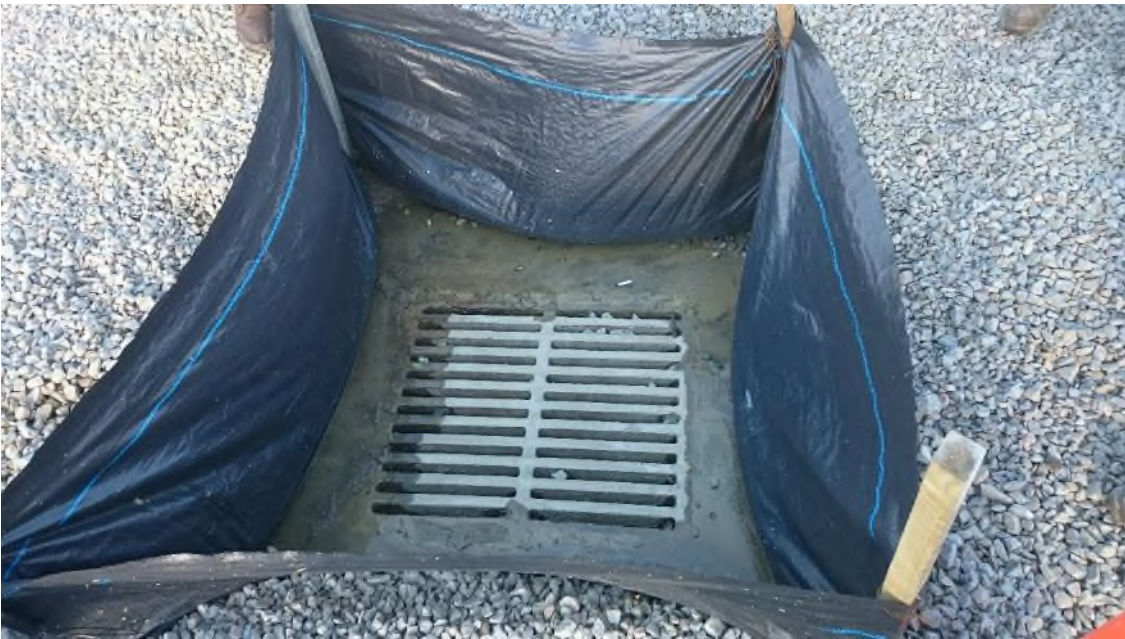
**Photograph 78. Hopewell Regional Wastewater Treatment Plant Construction Site: Inlet protection around storm drain connected to sediment basin.**

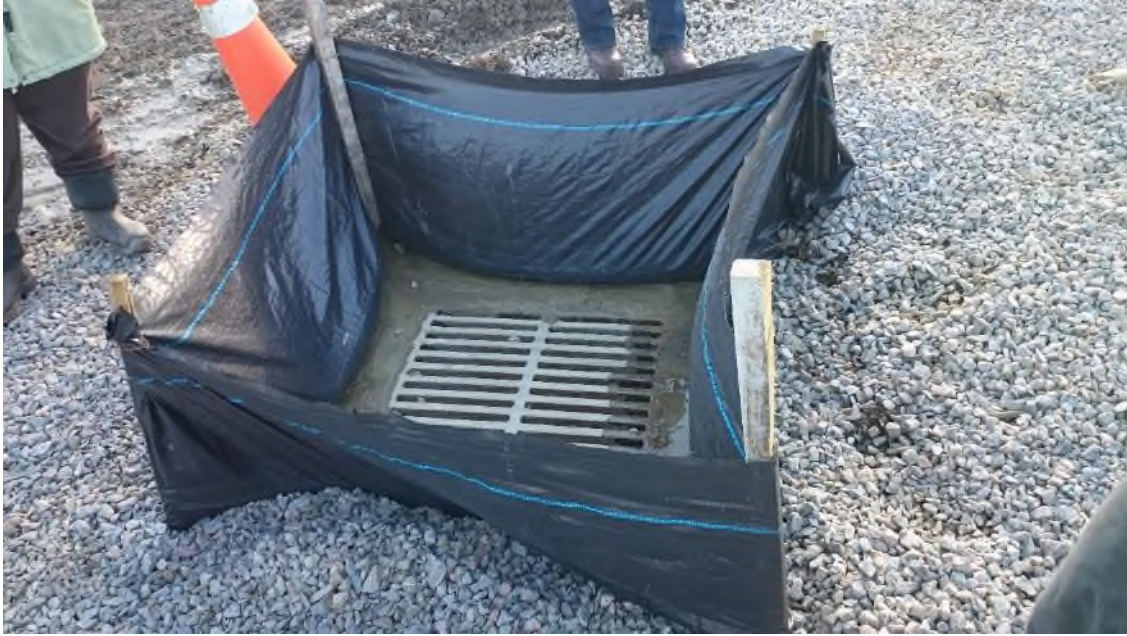
**Photograph 79. Hopewell Regional Wastewater Treatment Plant Construction Site:  
Alternate view of inlet protection.**

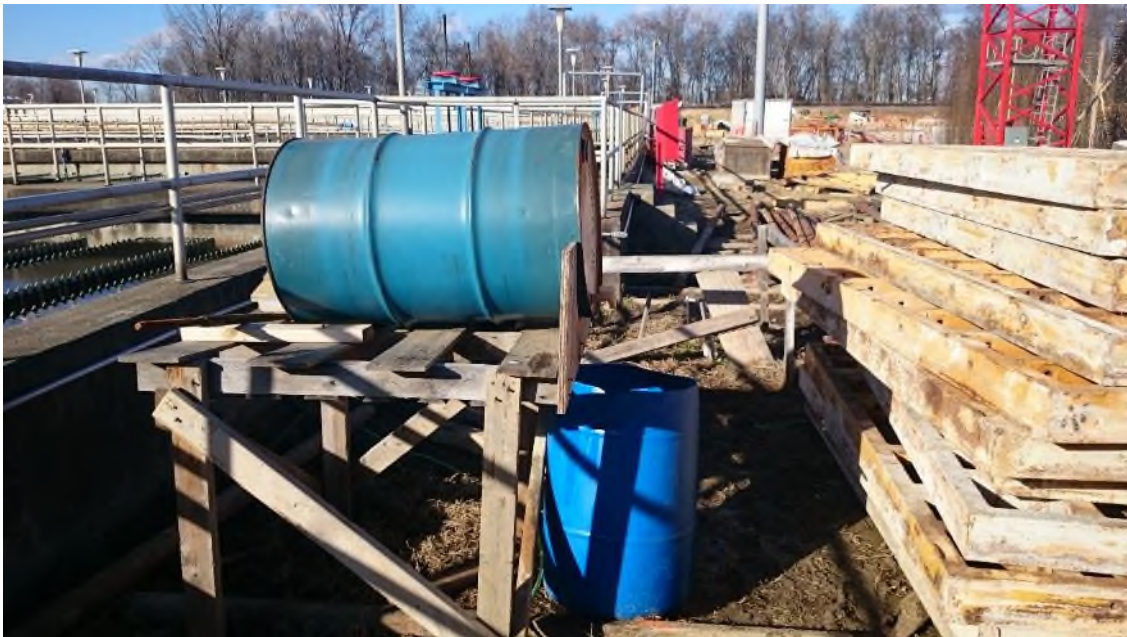
**Photograph 80. Hopewell Regional Wastewater Treatment Plant Construction Site: Oil  
barrel with overflow into a secondary containment barrel.**

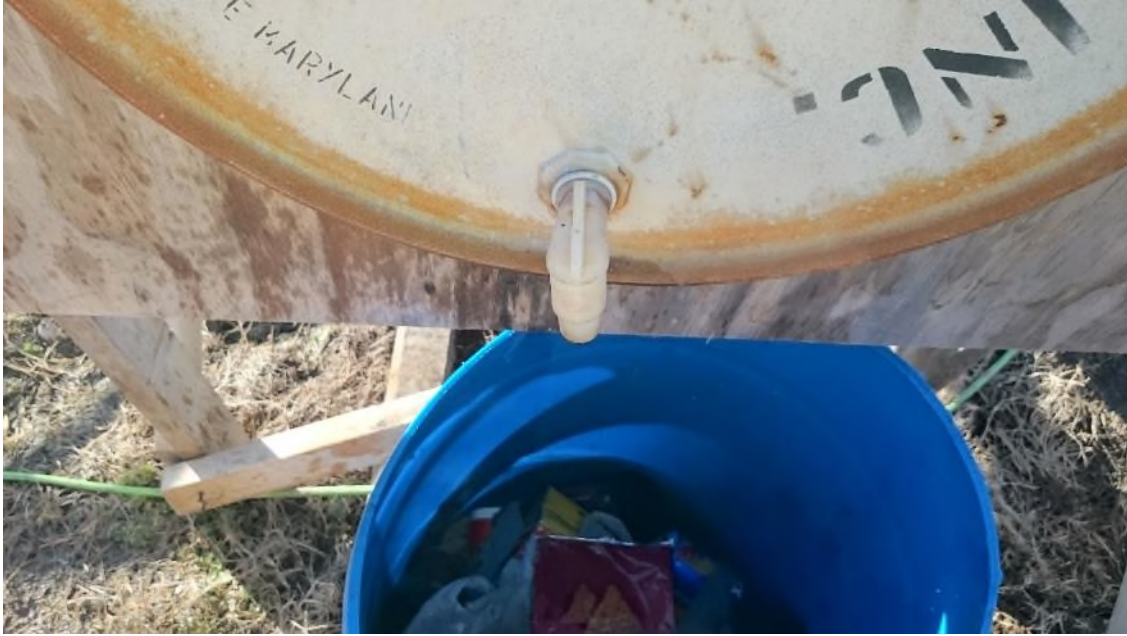
**Photograph 81. Hopewell Regional Wastewater Treatment Plant Construction Site: Oil barrel with overflow into a secondary containment barrel.**

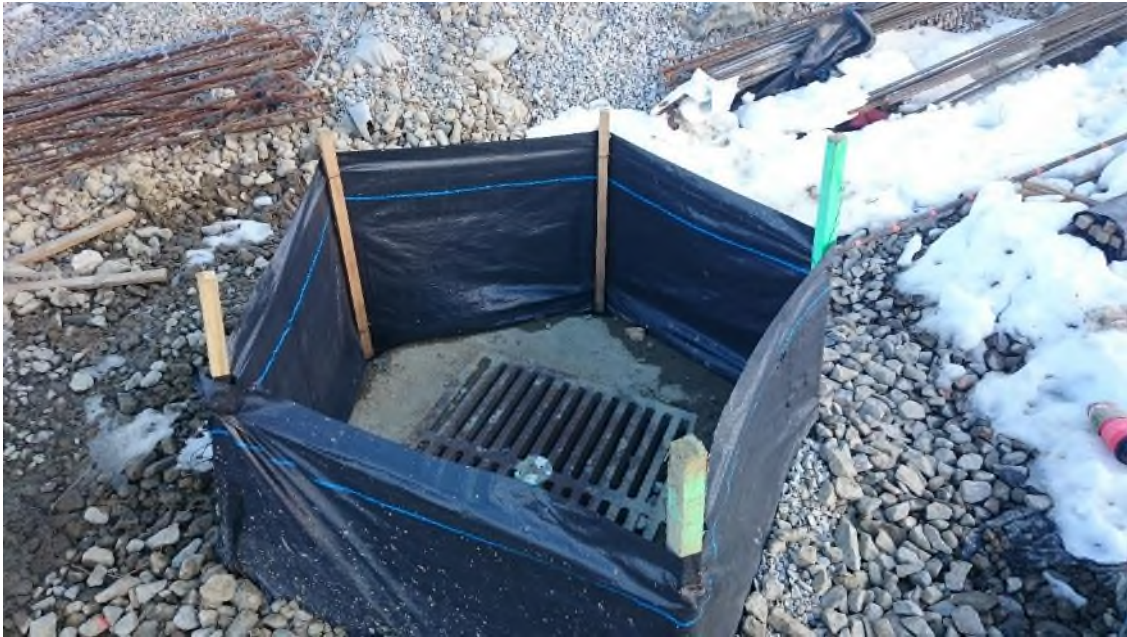
**Photograph 82. Hopewell Regional Wastewater Treatment Plant Construction Site: Inlet protection around storm drain connected to sediment basin.**

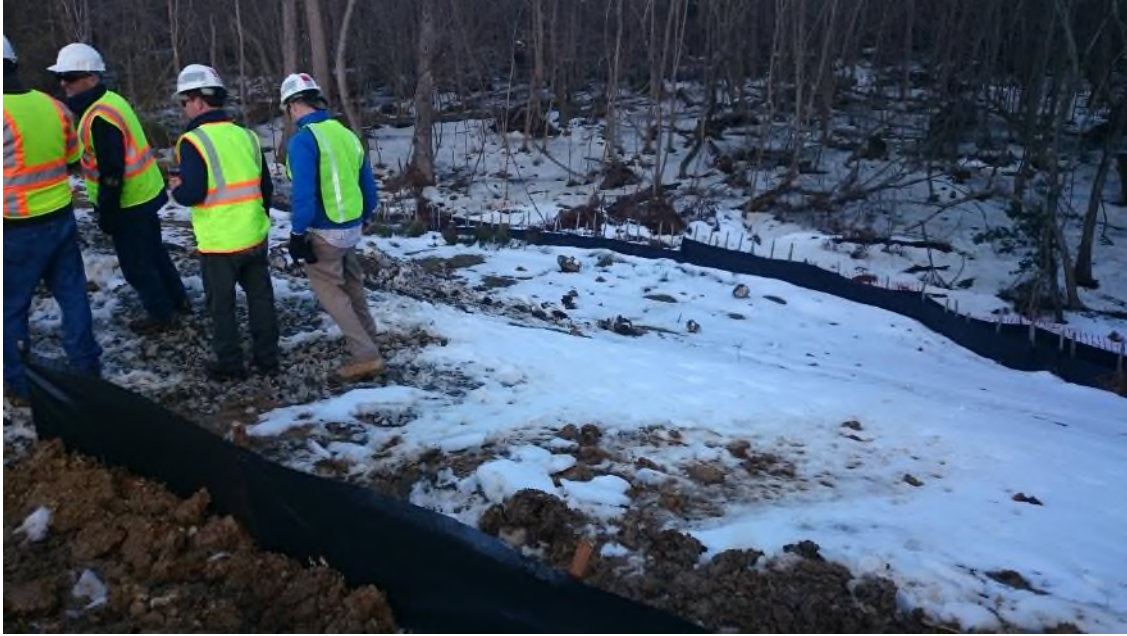
**Photograph 83. Hopewell Regional Wastewater Treatment Plant Construction Site: Silt fence and a wetland located at bottom of site.**

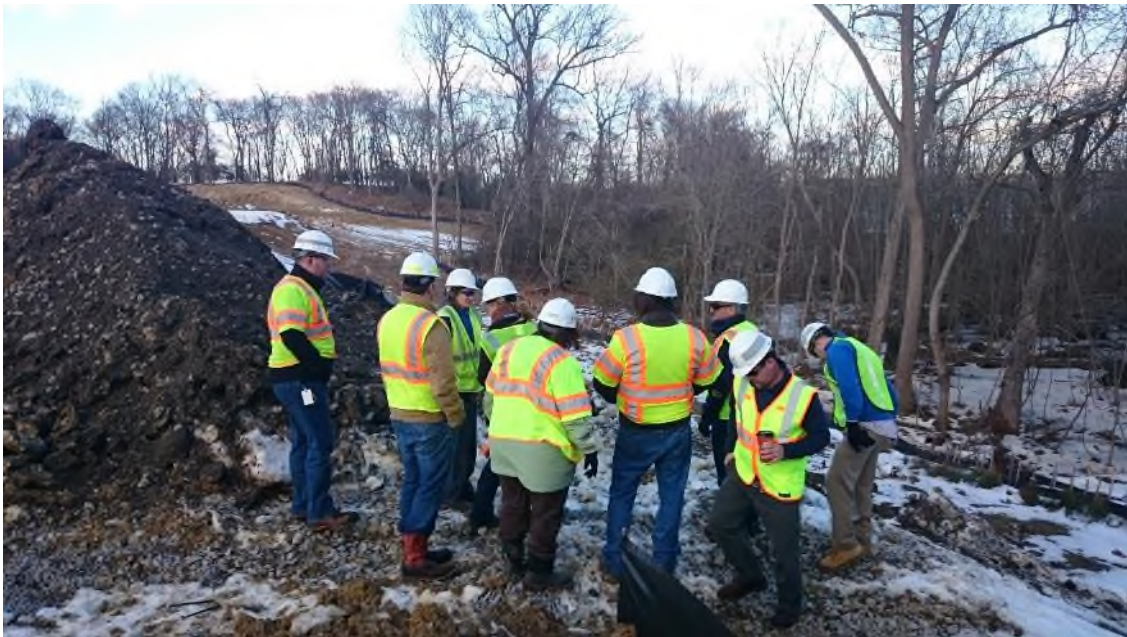
**Photograph 84. Hopewell Regional Wastewater Treatment Plant Construction Site: Silt fence and a wetland located at bottom of site.**

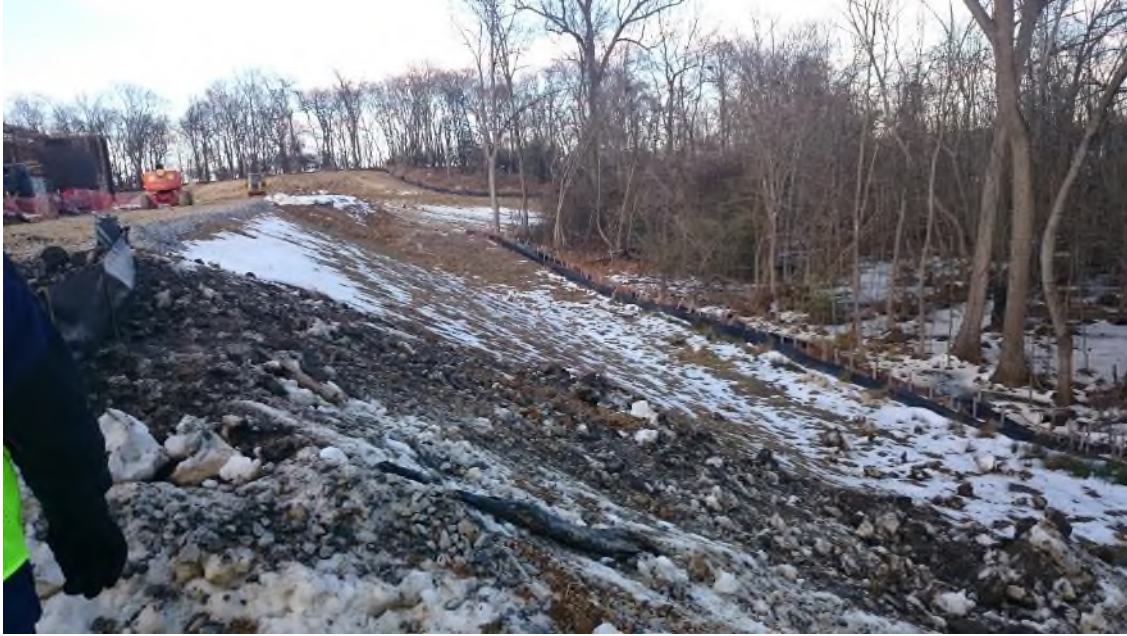
**Photograph 85. Hopewell Regional Wastewater Treatment Plant Construction Site: Silt fence and a wetland located at bottom of site.**

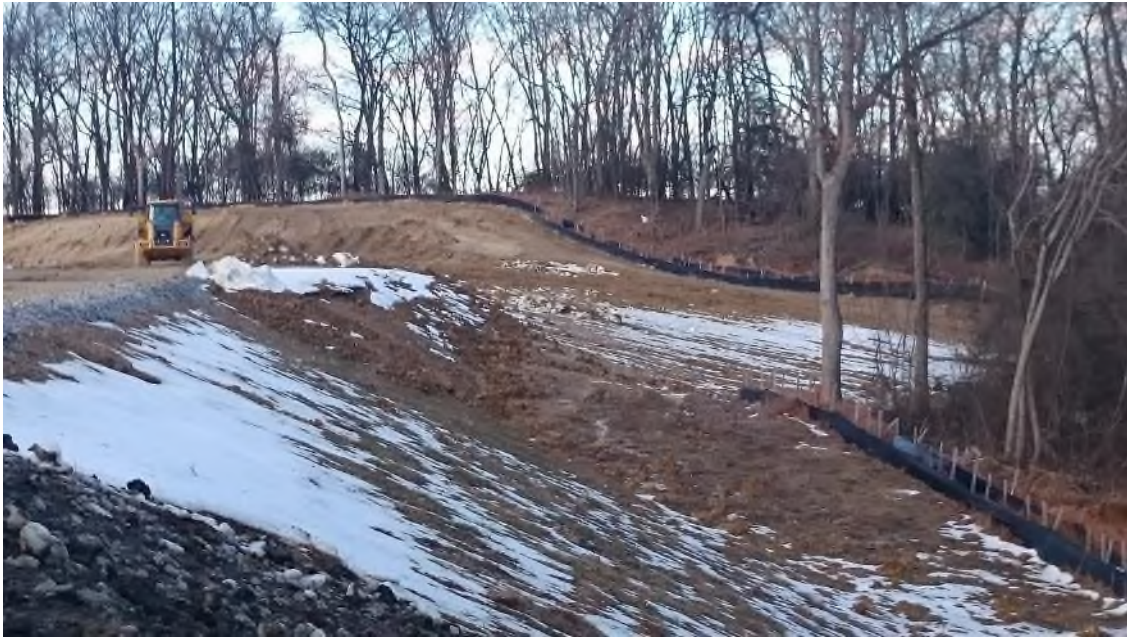
**Photograph 86. Hopewell Regional Wastewater Treatment Plant Construction Site: Silt fence and a wetland located at bottom of site.**

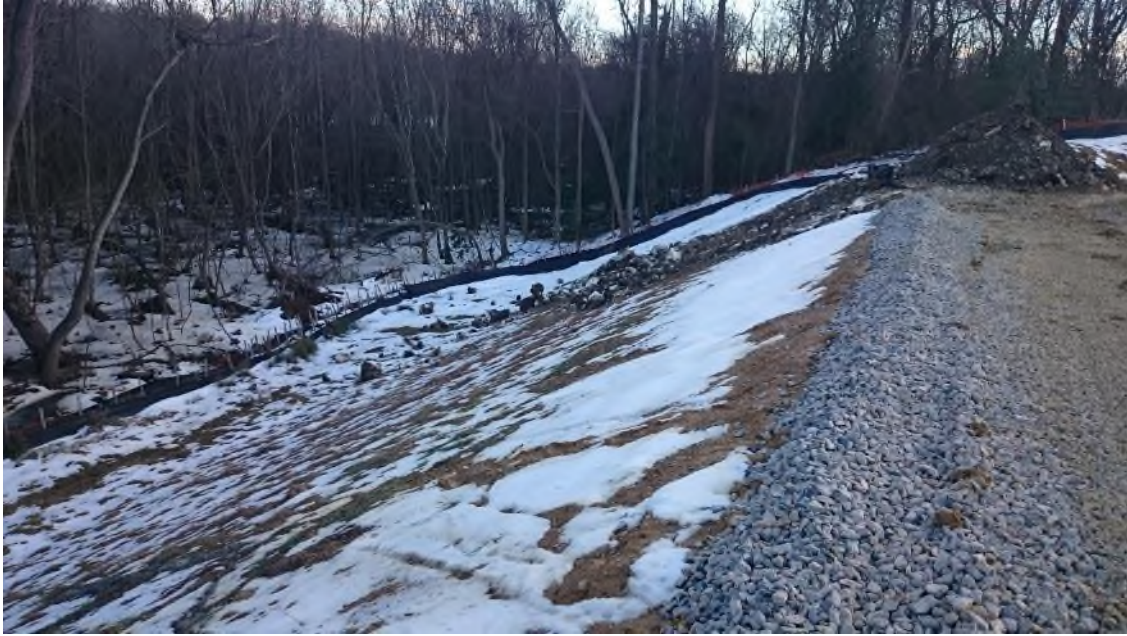
**Photograph 87. Hopewell Regional Wastewater Treatment Plant Construction Site: Silt fence and a wetland located at bottom of site.**

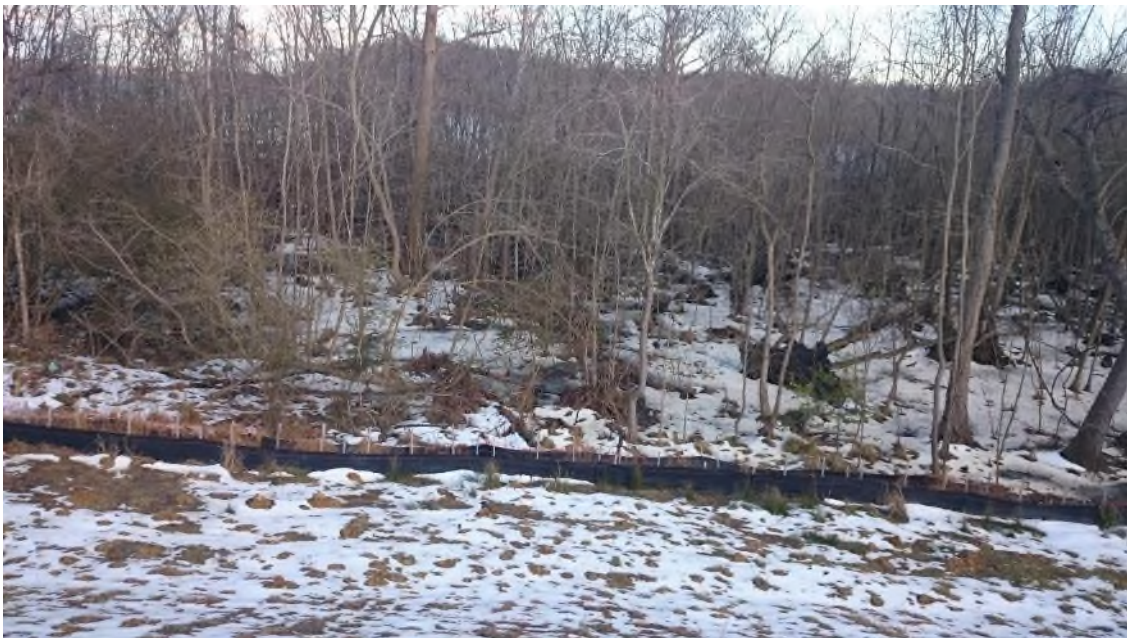
**Photograph 88. Hopewell Regional Wastewater Treatment Plant Construction Site: Silt fence and a wetland located at bottom of site.**

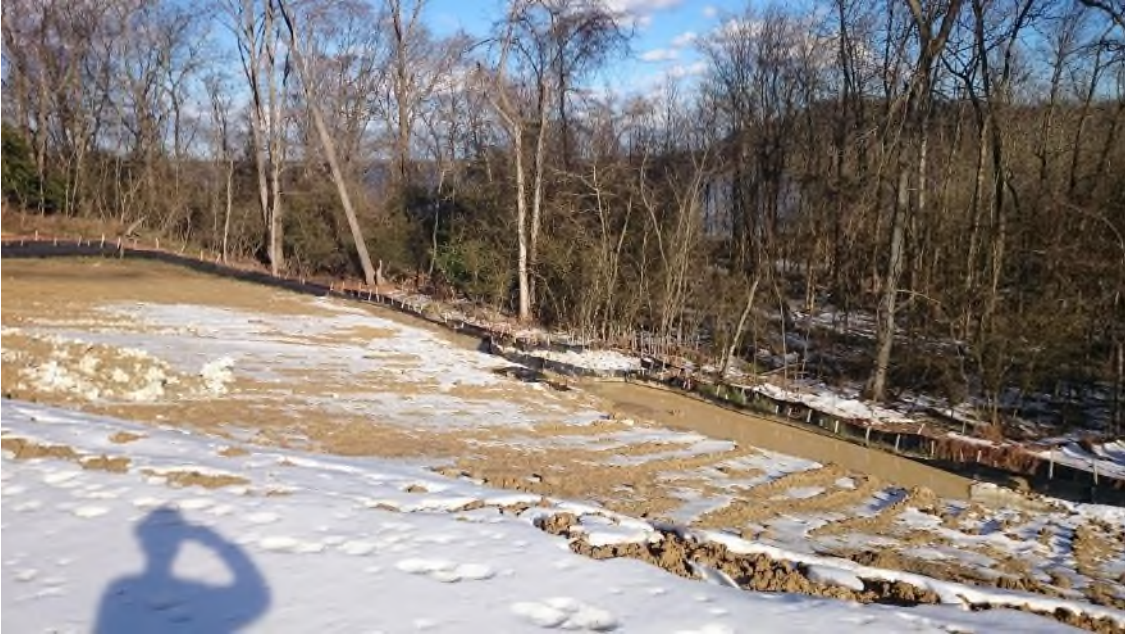
**Photograph 89. Hopewell Regional Wastewater Treatment Plant Construction Site: On the far side of the embankment from Photographs 83-88, showing location of former temporary sedimentation basin 3.**

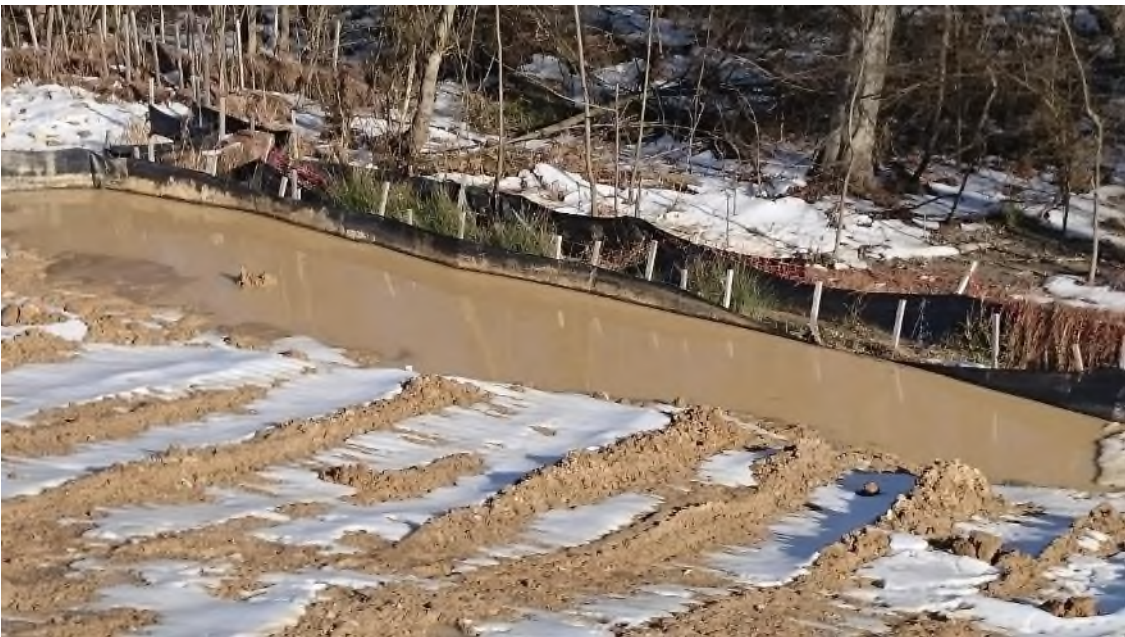
**Photograph 90. Hopewell Regional Wastewater Treatment Plant Construction Site: On the far side of the embankment from Photographs 83-88, showing location of former temporary sedimentation basin 3.**

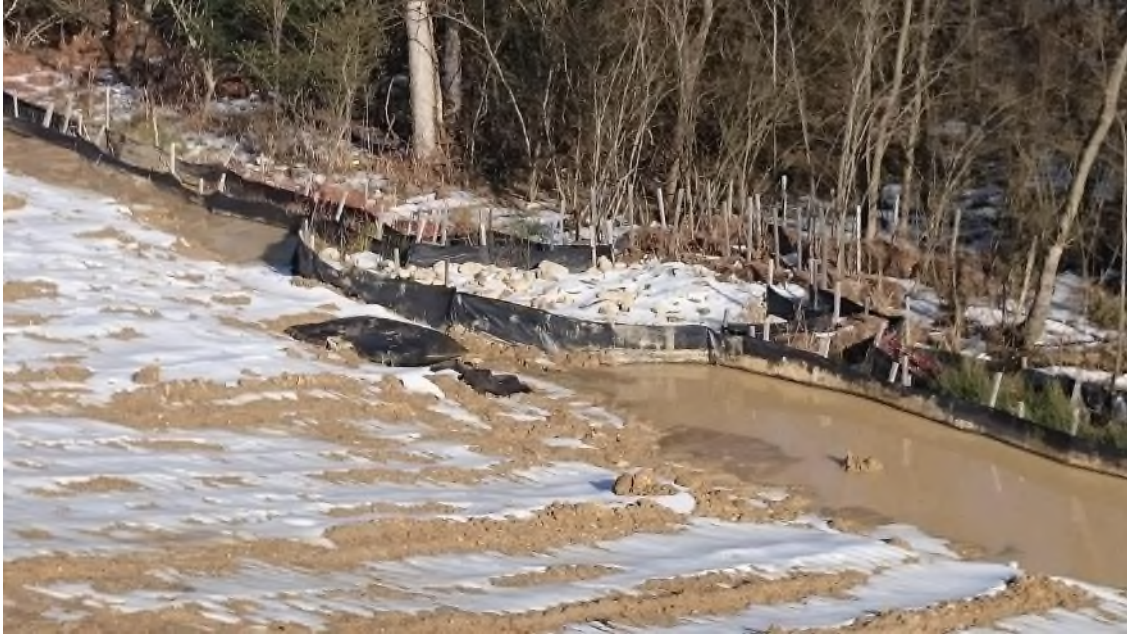
**Photograph 91. Hopewell Regional Wastewater Treatment Plant Construction Site: On the far side of the embankment from Photographs 83-88, showing location of former temporary sedimentation basin 3.**
